Manhole Inspection Summary

Manhole # S29EE_017MH

Insp Date: **1/5/07 9:55 AM**

Location Address: **1423 MOSHER ST**

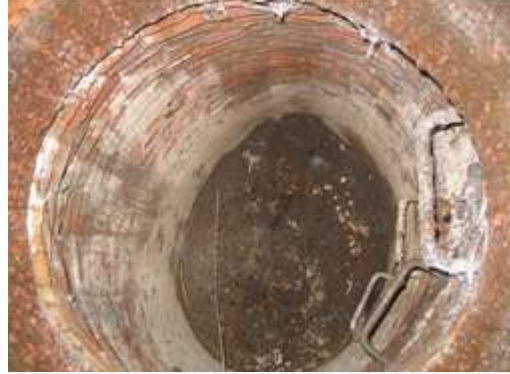
Top View

Channel debris.

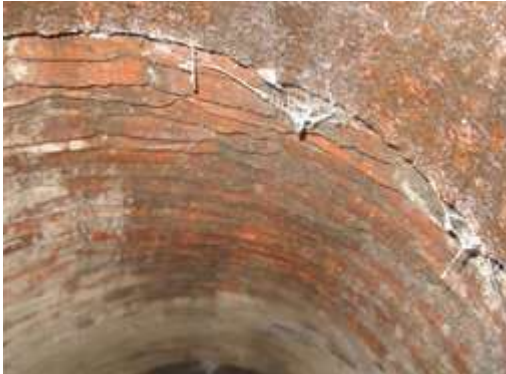
Defect

Frame leaks. Adjustment and Barrel infiltration.

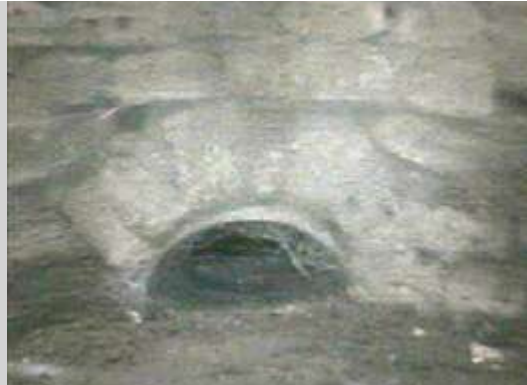
8 in. Circular Gravity Sewer
Pipe Out @ 12 O'Clock

Deposits: ☐ None ☒ **Mud** ☐ Sludge ☒ **Debris** ☐ Grease

Silt Depth: **4** (in.) Deposits Extent: **Medium**

Infiltration: **Evidence** Pipe Seal Cond: **Unknown**
